QUILPIE DRINKING WATER QUALITY MANAGEMENT PLAN

Service Provider ID 108

**GBA Project/Doc ID no. 200004 /
337565**

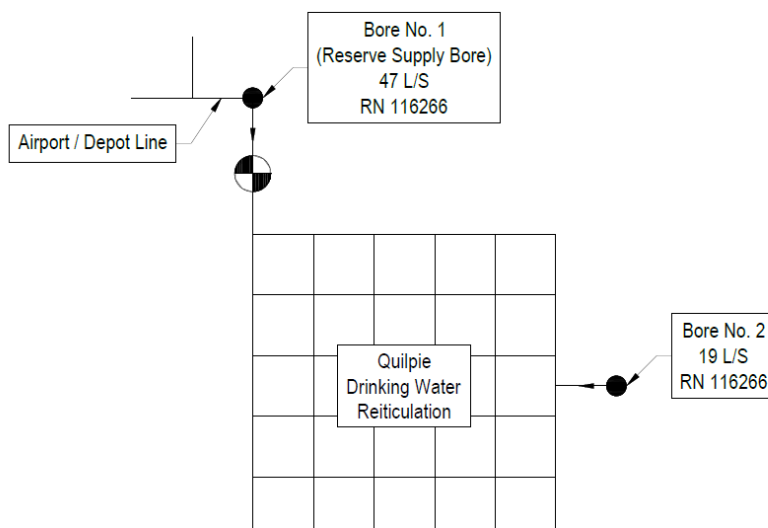
Figure 2.1 Quilpie Service Schematic Layout Source, Treatment and Distribution Details

Figure 2.1 shows a schematic of the Quilpie's Water Supply Scheme. Refer to Appendix B for water supply layouts superimposed on aerial photos.

Bore 2 is the primary water source for Quilpie's water supply scheme supplying the majority of the town. Bore 1's primary function is as a backup water supply in case of bore 2 failure. Bore 1 however is utilised on an ongoing basis to provide water to a small section of the reticulation system on the NW side of Quilpie, providing water to Quilpie Airport and the new council depot. The supply is restricted by a sluice valve running adjacent to bore 1 directing water to the new depot and airport.

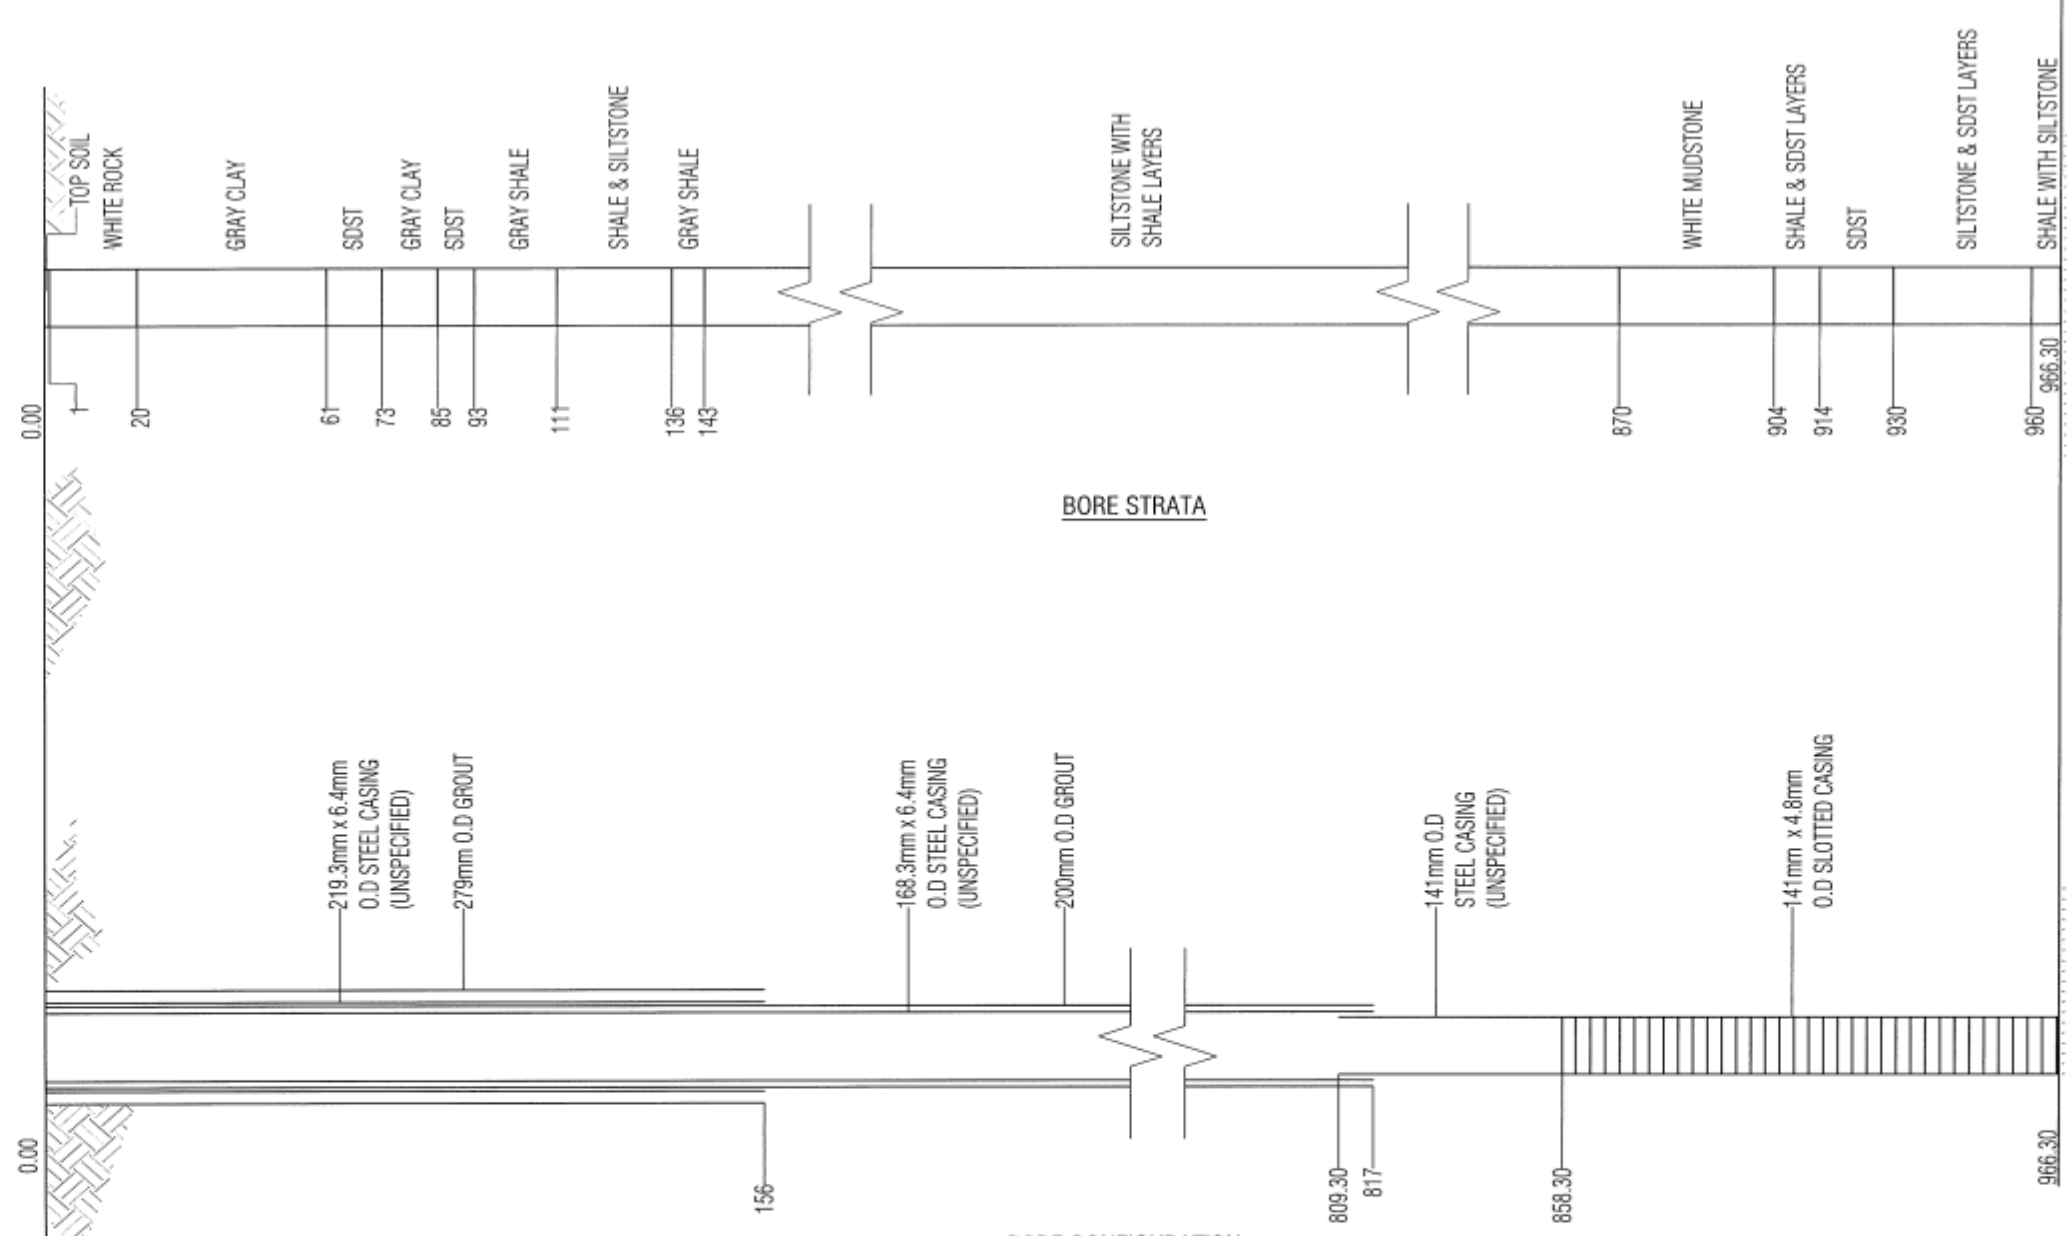
APPENDIX D
BORE CASING AND STRATA DETAILS

DATE DRILLED: 07/03/2009
 DRILLERS NAME: TAYLER, STEPHEN CHARLES
 DRILL COMPANY: DALY BROS
 METHOD OF CONST.: MUD ROTARY
 LOCATION - EASTING: 228555
 NORTHING: 7052981
